**DENEY SERTİFİKASI / Test Certificate**

Numunenin Adı ve Tarifi / Sample's Name & Description: Asistal TH 78 Door and Window System  
( Tilt & Turn )

Uygulanan Normlar / Norms Applied: TS EN 14351-1+A1, TS EN 1026, TS EN 1027, TS 4644 EN 12211

Sonuçlar / Results:  
TS EN 12207 - Air Permeability : Class 4 ( 600Pa )  
TS EN 12208 - Watertightness : Class 9A ( 600Pa )  
TS EN 12210 - Resistance to Wind Load : Class C3 ( 1200Pa )  
TS EN 12210 - Resistance to Safety Load : OK ( 1800Pa )

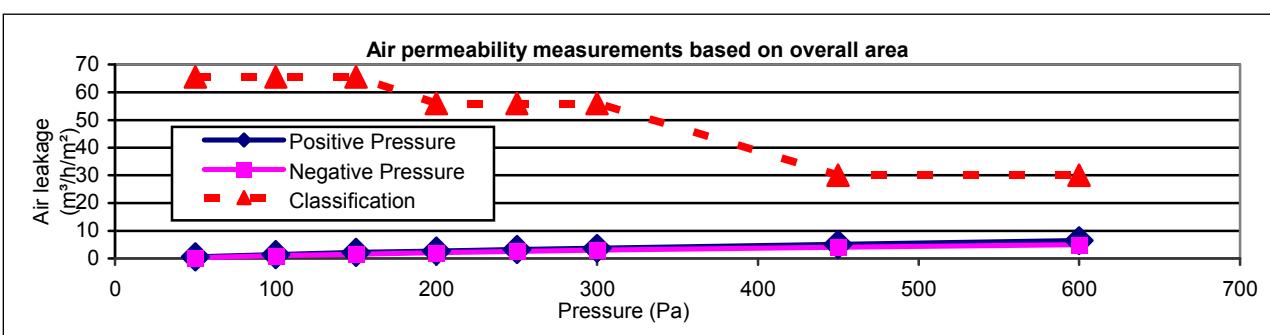
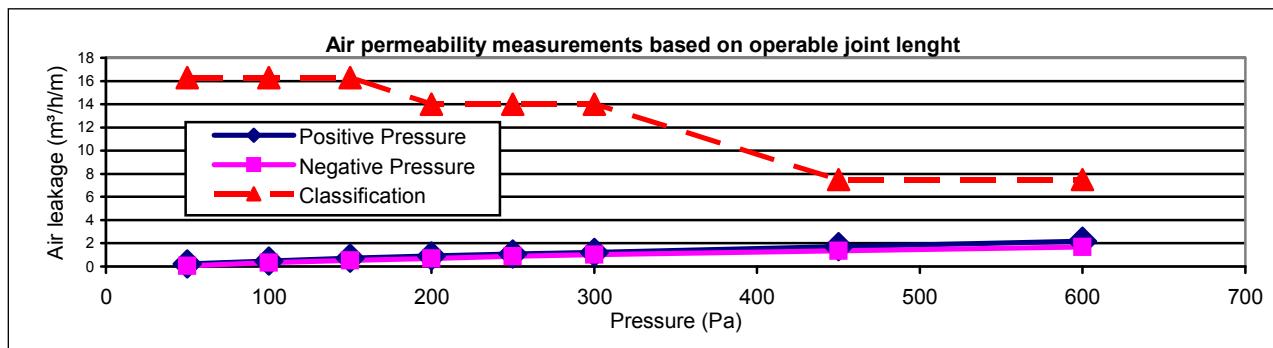
NEGATIVE PRESSURE			
$\phi_4$	Test Pressure (Pa)	Air Leakage (m³/h)	Air Leakage (m³/h/m)
$\phi_4$	50	0,34	0,06
$\phi_4$	100	1,79	0,33
$\phi_4$	150	2,77	0,51
$\phi_4$	200	3,78	0,70
$\phi_4$	250	4,69	0,87
$\phi_4$	300	5,53	1,02
$\phi_4$	450	7,40	1,36
$\phi_4$	600	9,04	1,67

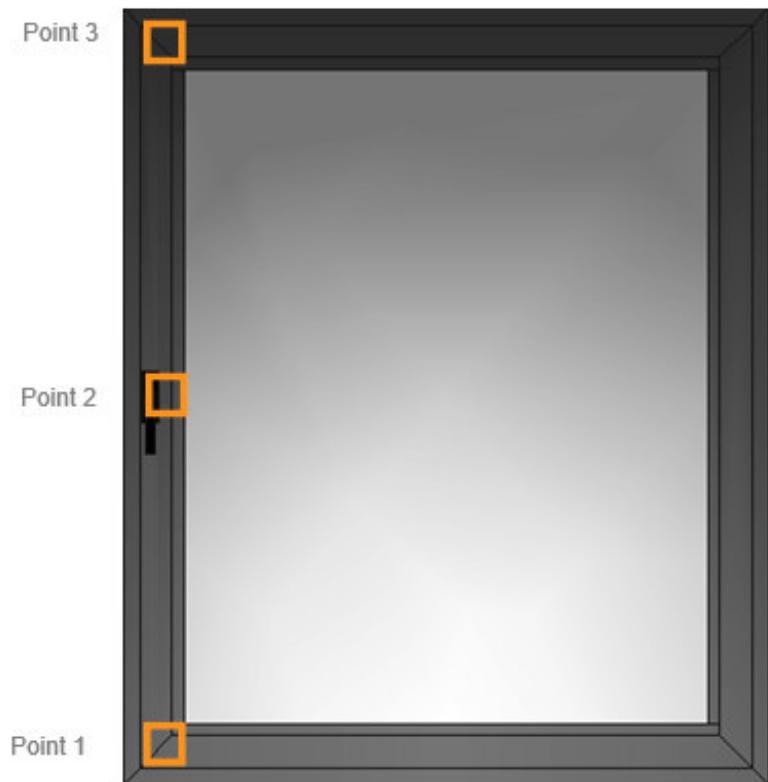
**Figure 1.** The view of specimen's frontal deflection's measurements location

X coordinates (mm)	Y coordinates (mm)
External Dimensions	1230	1480
Sensor 1 Replacement	80	80
Sensor 2 Replacement	80	740
Sensor 3 Replacement	80	1415

Position: Vertical distance for mullion at middle axis

Scale: **Vertical      1480 mm**

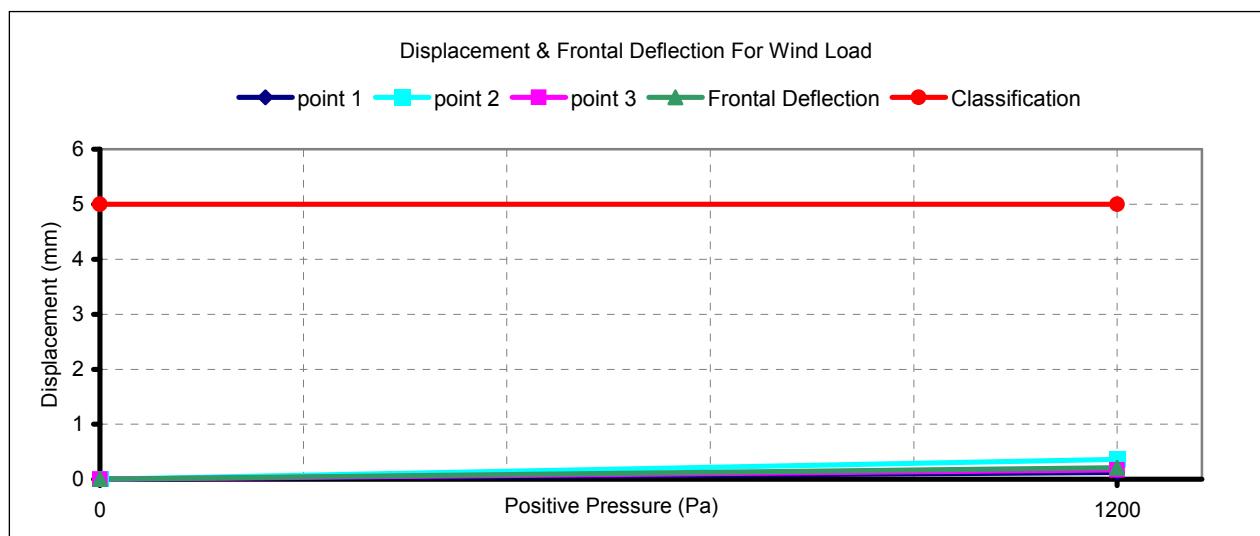
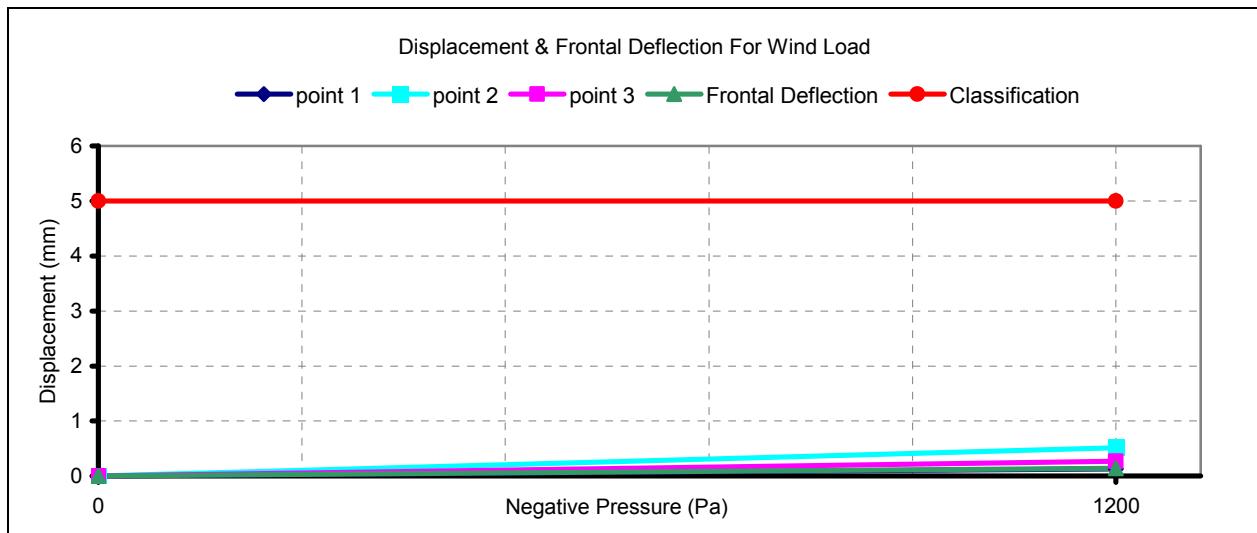
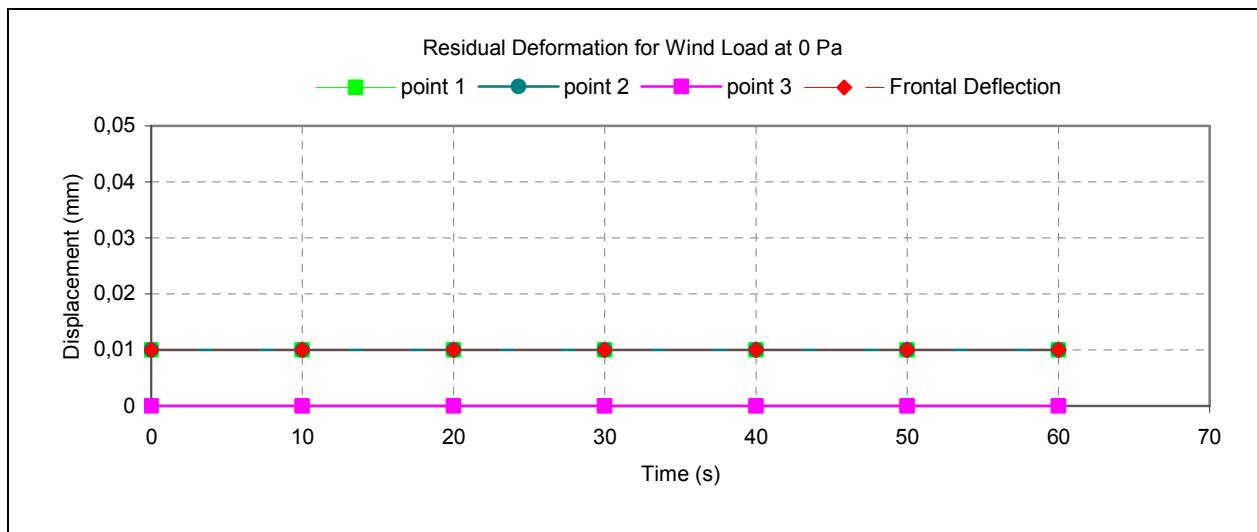
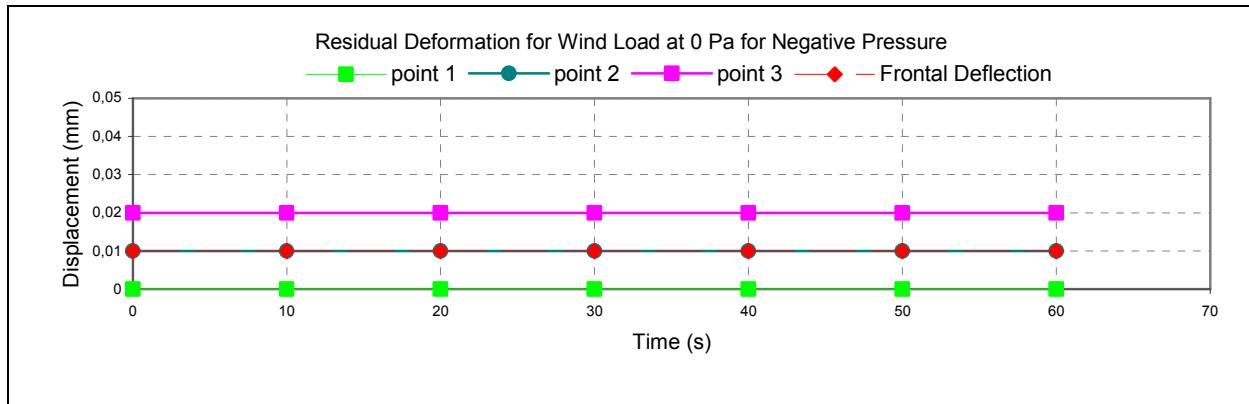
Positive Pressure (Pa)	Point 1 (mm)	Point 2 (mm)	Point 3 (mm)	Frontal Deflection $\lambda_1$ (mm)	Negative Pressure (Pa)	Point 1 (mm)	Point 2 (mm)	Point 3 (mm)	Frontal Deflection $\lambda_2$ (mm)
0	0,0	0,0	0,0	0,0	0	0,0	0,0	0,0	0,0
1200	0,12	0,36	0,17	0,21	1200	0,13	0,51	0,27	0,14
0	0,01	0,01	0,00	0,01	0	0,00	0,01	0,02	0,01

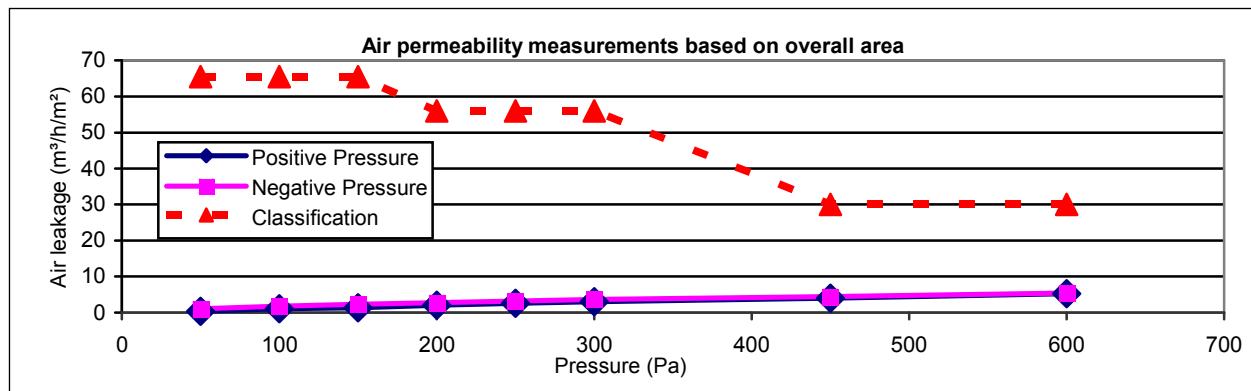
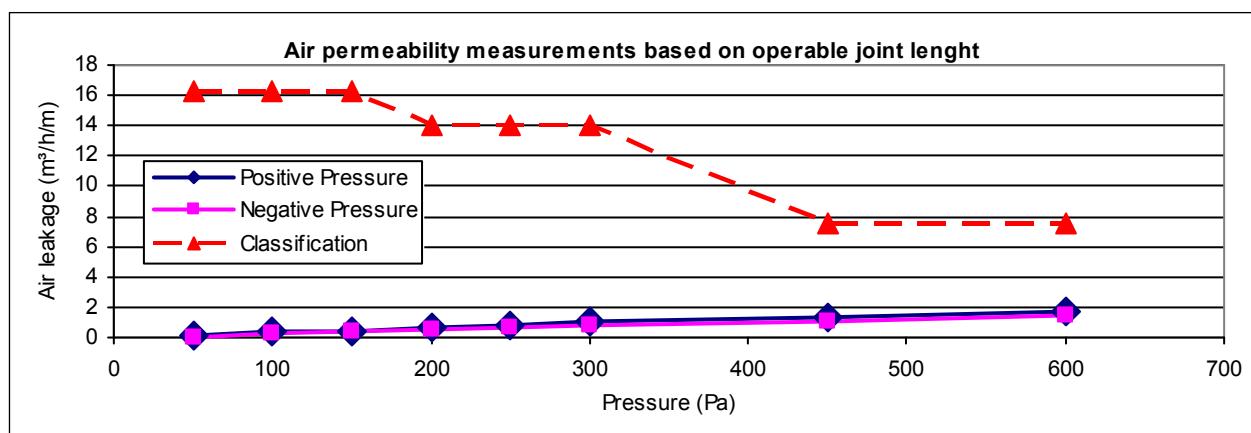
NEGATIVE PRESSURE			
$\phi_8$	Test Pressure (Pa)	Air Leakage (m³/h)	Air Leakage (m³/h/m)
$\phi_8$	50	0,07	0,01
$\phi_8$	100	1,14	0,21
$\phi_8$	150	2,17	0,40
$\phi_8$	200	3,00	0,55
$\phi_8$	250	3,80	0,70
$\phi_8$	300	4,52	0,83
$\phi_8$	450	6,04	1,11
$\phi_8$	600	7,74	1,43
